**CH-21A HELICOPTER AIRFRAME DEFORMATION
UNDER A DYNAMIC CRASH CONDITION**

Pertaining to the Dynamic Crash Test of a U. S. Army CH-21A Helicopter

TRECOM Technical Report 63-77

Technical Report
AvSER 63-3

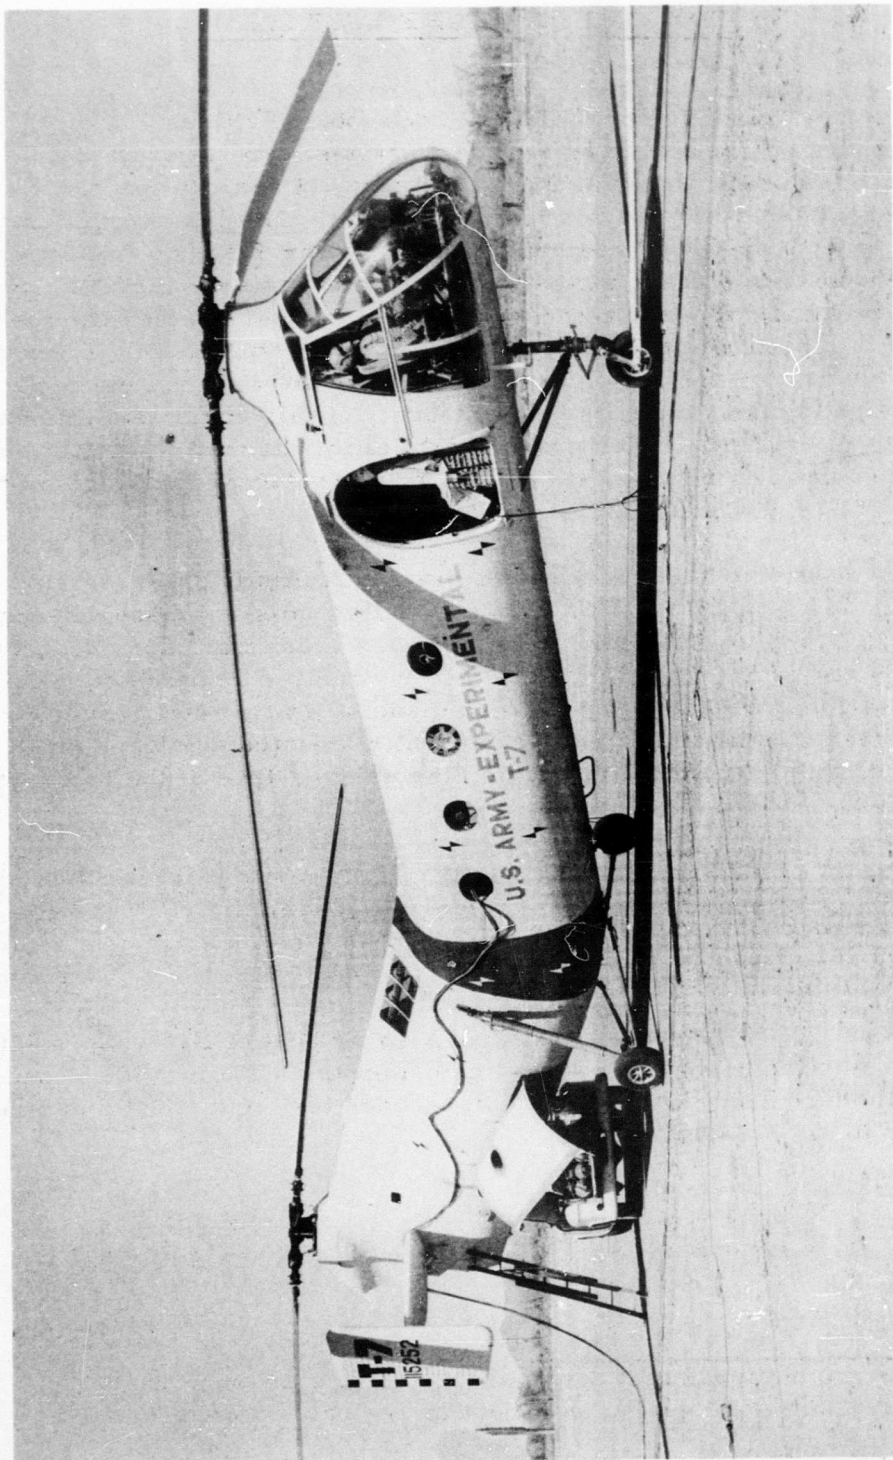
Figure 1. Test Vehicle Prior to Crash.

Note the various markings on the fuselage which aid in the study of structural deformation during crash.

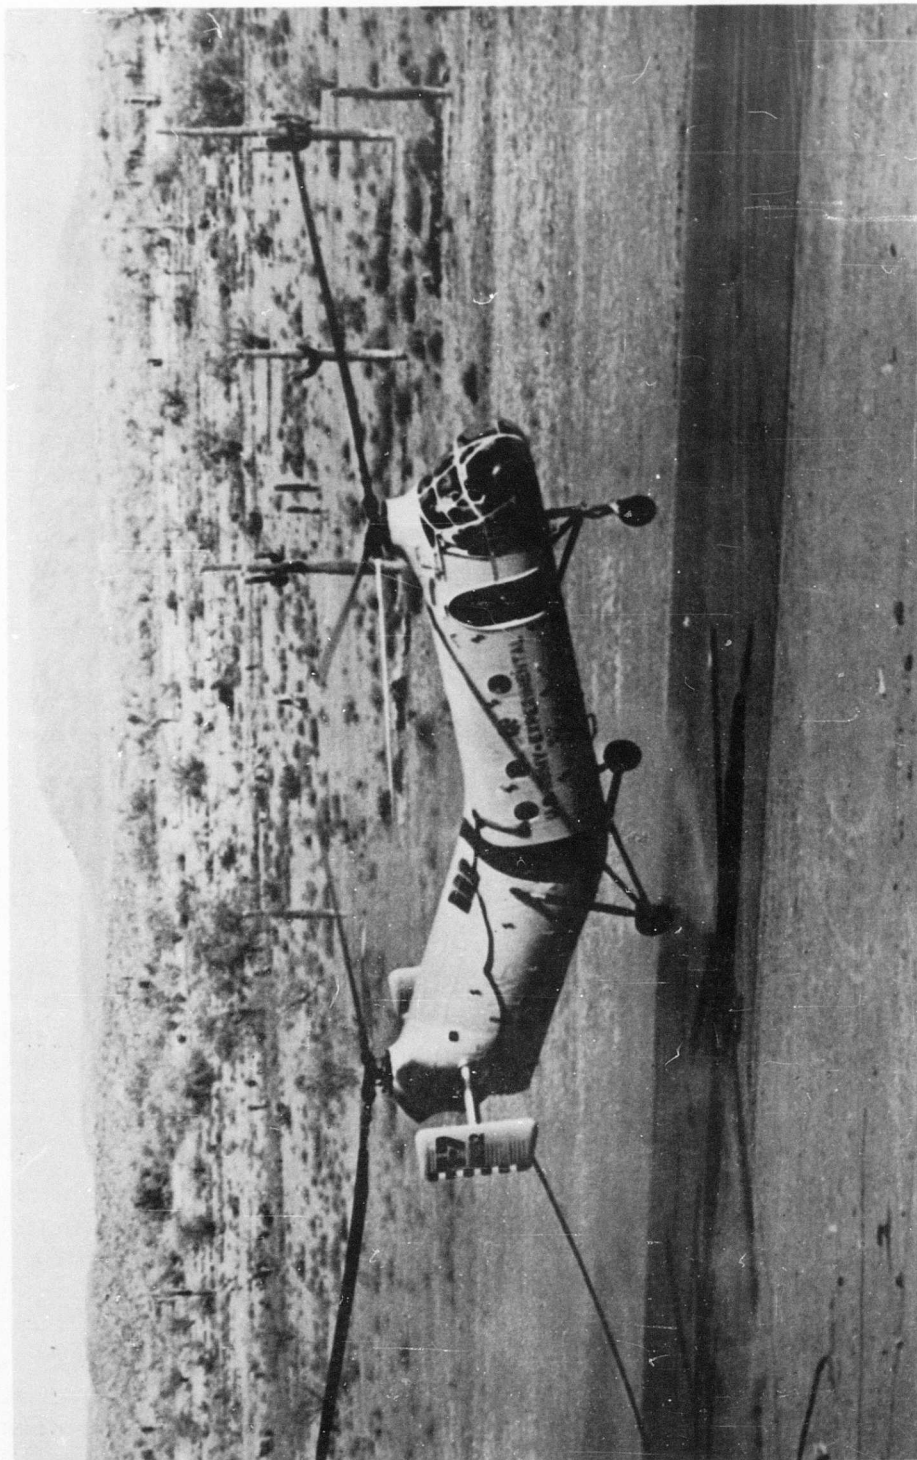
Figure 3. Test Vehicle Just After Lift-Off.

Note trailing umbilical cable through which all data were recorded during actual crash sequence.

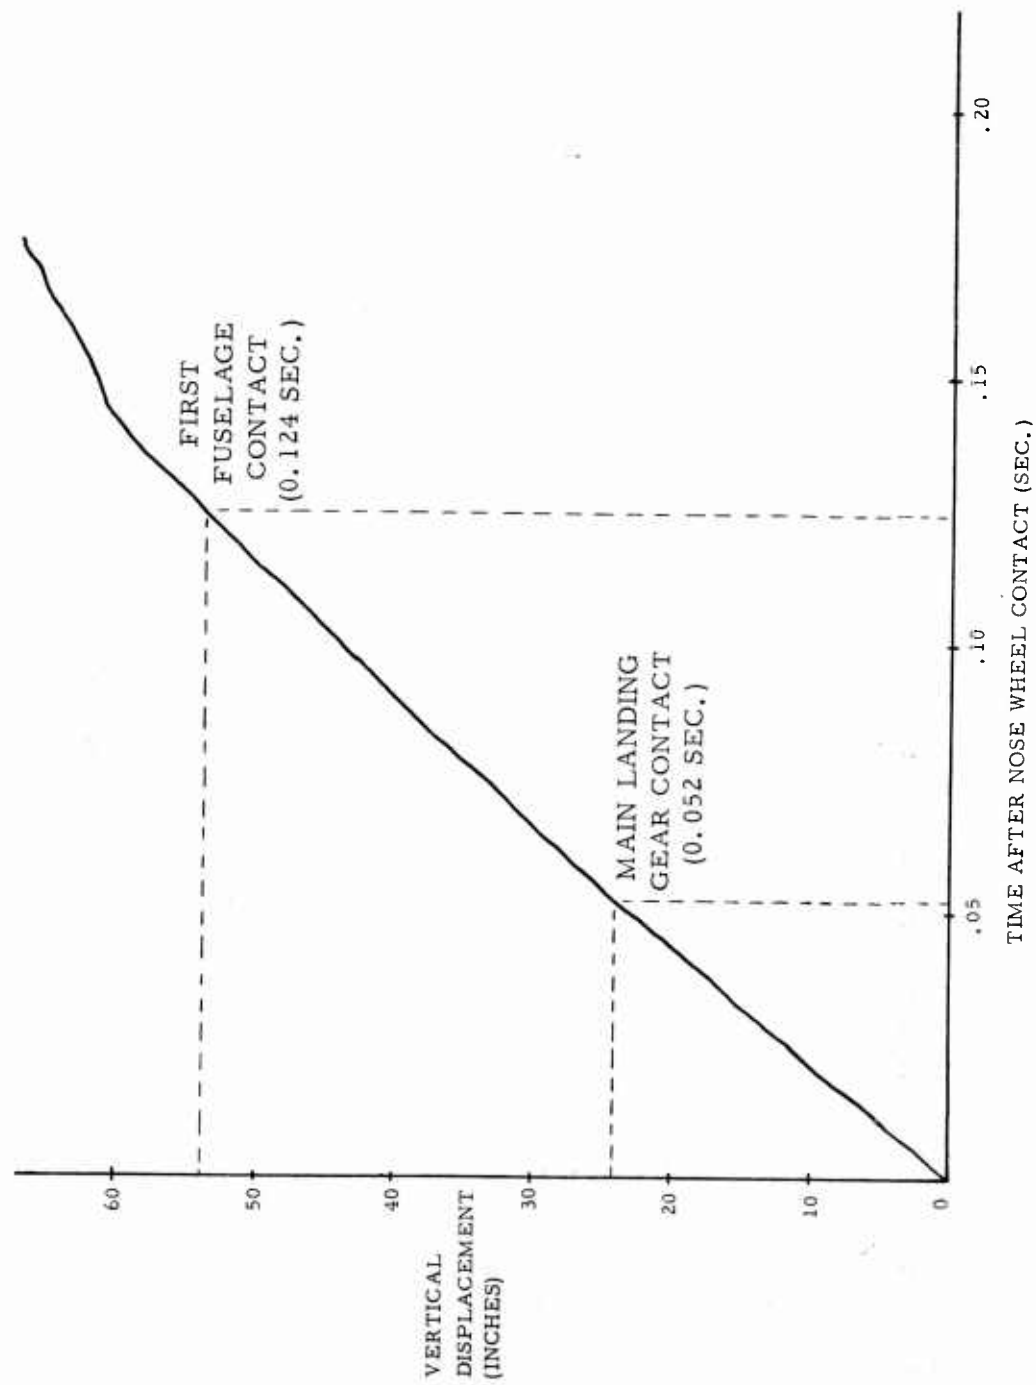
Figure 27. Vertical Displacement vs. Time, Cargo Compartment Floor.

With a CH-21A in the same attitude as the crash attitude, the vertical distance between the bottom of the nose gear and the bottom of the main gear is approximately 24.5 inches. The distance between the bottom of the main gear and the bottom of the fuselage at the point where the fuselage contacted the ground is approximately 29.0 inches, and the vertical distance between the bottom of the fuselage and the cargo compartment floor at the location of the accelerometer, fuselage station 270, is approximately 18 inches. Thus, the total possible vertical displacement of this accelerometer was approximately 70.5 inches. The difference between the computed vertical displacement and this maximum measured value is 4.65 inches. Postcrash observation placed the floor of the fuselage approximately 5 inches above the runway at the location of the accelerometer mount. The close correlation of both velocity change information and vertical displacement data as obtained from two separate sources is added proof of the validity of this accelerometer data.
